FLOOD WATCH 2017: Alton Public Works continues to monitor flood water downtown

by Dan Brannan, Content Director
May 5 2017 6:15 AM

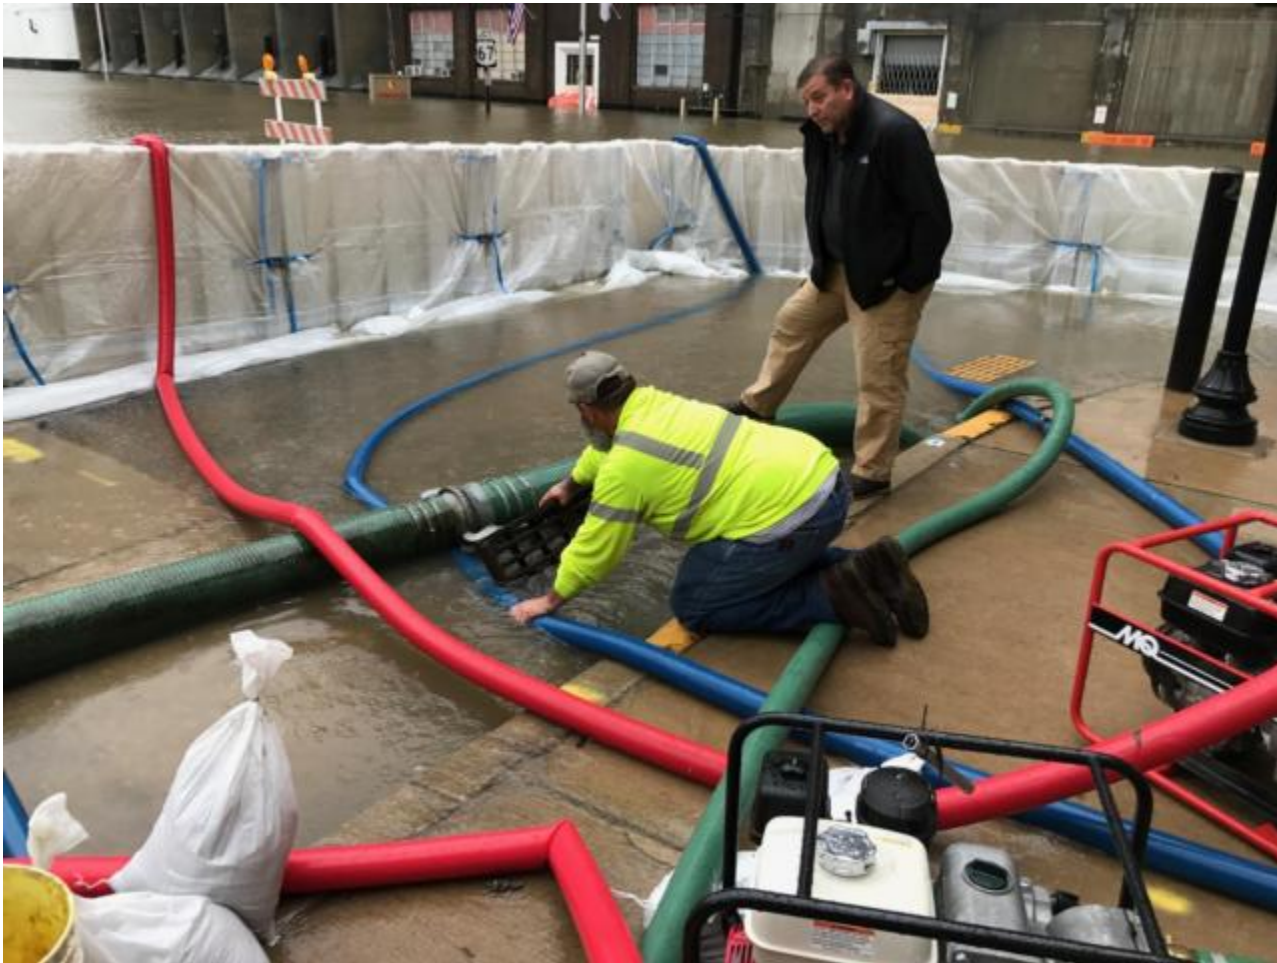
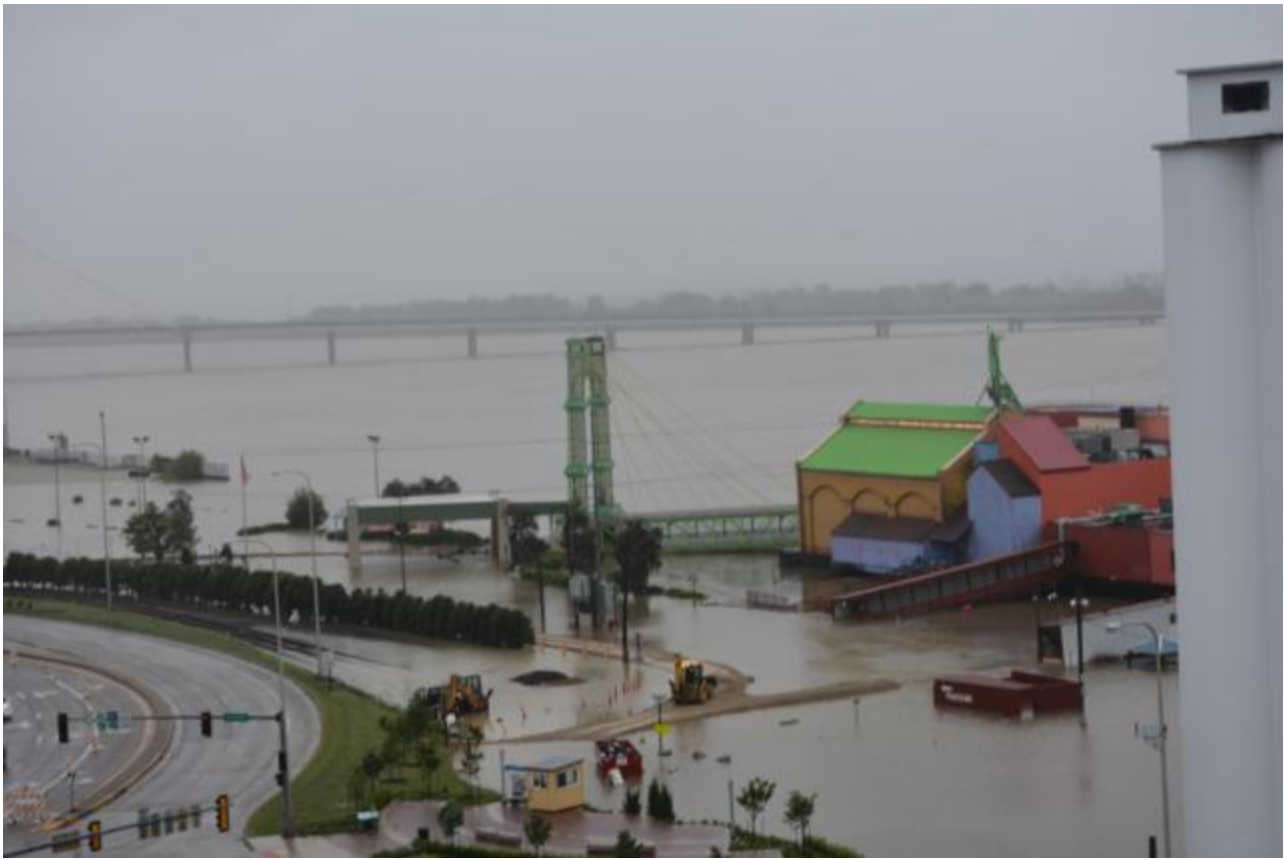
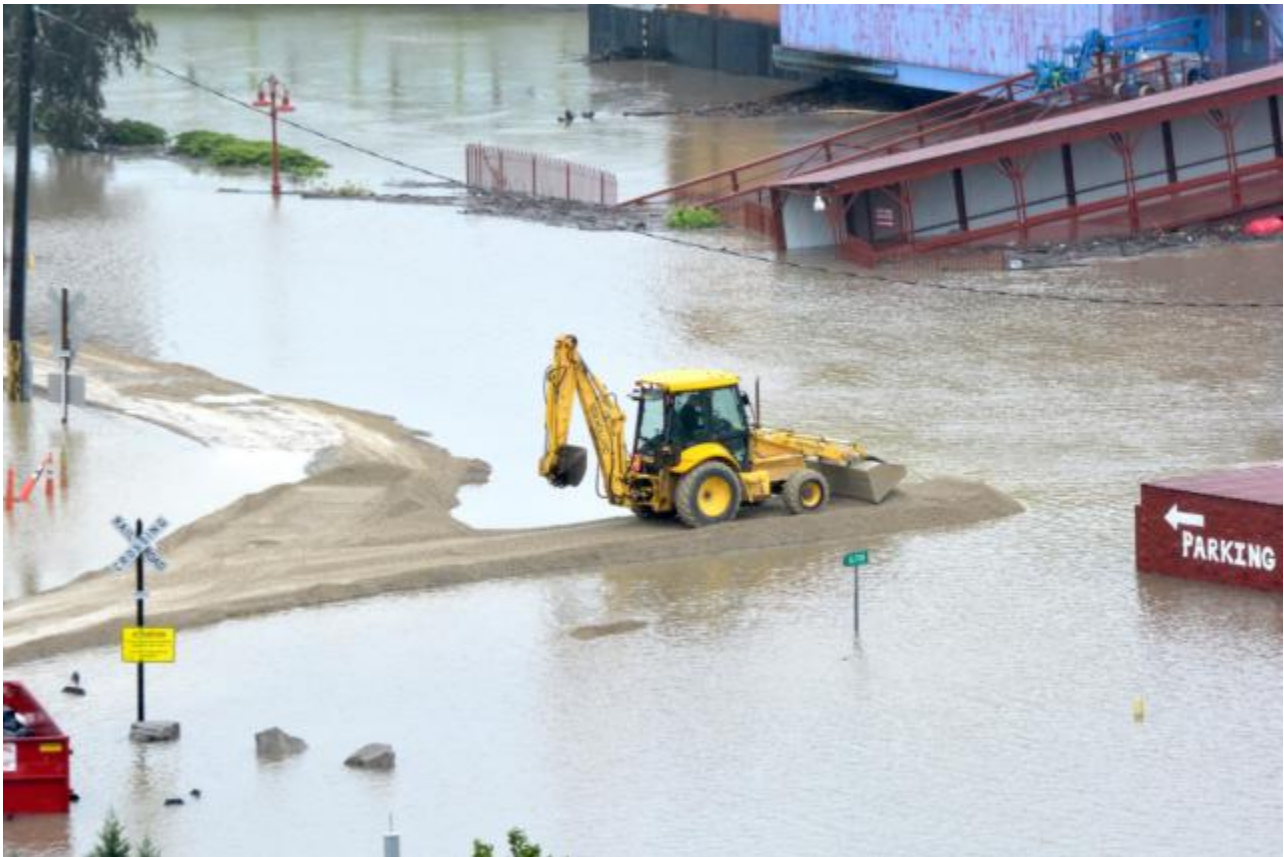
ALTON - The Alton Public Works staff members are closely watching a Muscle Wall constructed across from Ardent Mills and in front of Morrison's in Downtown Alton.

So far, the wall is working and doing what it is supposed to do: holding back the flood water, Alton Public Works Director Bob Barnhart said.

The portable plastic barricades in the Muscle Wall are positioned in segments, much in the same fashion as side-by-side Lego blocks, Barnhart said. The cost of the wall is an estimated \$100 a foot or \$20,000 for all presently held by the city and are reusable.

"As long as we can keep up with the seepage of the backside of the wall we should be in good shape," Barnhart said. "We are going to continue to do things the way we have in the past few years. The only difference is we separated the sanitary sewer system and have different locations to be concerned with. We try to discharge water over the wall and stay ahead of the water that seeps in the backside."

Barnhart's Public Works' staff has used a new Muscle Wall around the path of flooding. The new Muscle Wall started with assistance from 400 sandbags and 700 were in reserve from the start.

The plastic barriers will not be effective against flooding rising above 36 feet, Barnhart said.

“We will monitor the elevations on the muscle wall and if we have to come in here and change our game plan and install Jersey barriers to increase the elevation of the wall, we will,” Barnhart said. “We constructed this away from buildings so we could get behind it if needed and build up. If things increase much more, we will have to begin building a wall down the alley of the CVB. Everything is going to plan right now. We will continue to watch the wall on a daily basis.”
